Purpose: CERCLA Screening Site Inspection

Site: Golden Eagle Refining Co., Inc.
21000 South Figueroa Street
Carson, California
Los Angeles County

FIT Investigators: Karen Johnson
Christine Houston
Rita Mundy

Date of Inspection: March 30, 1989

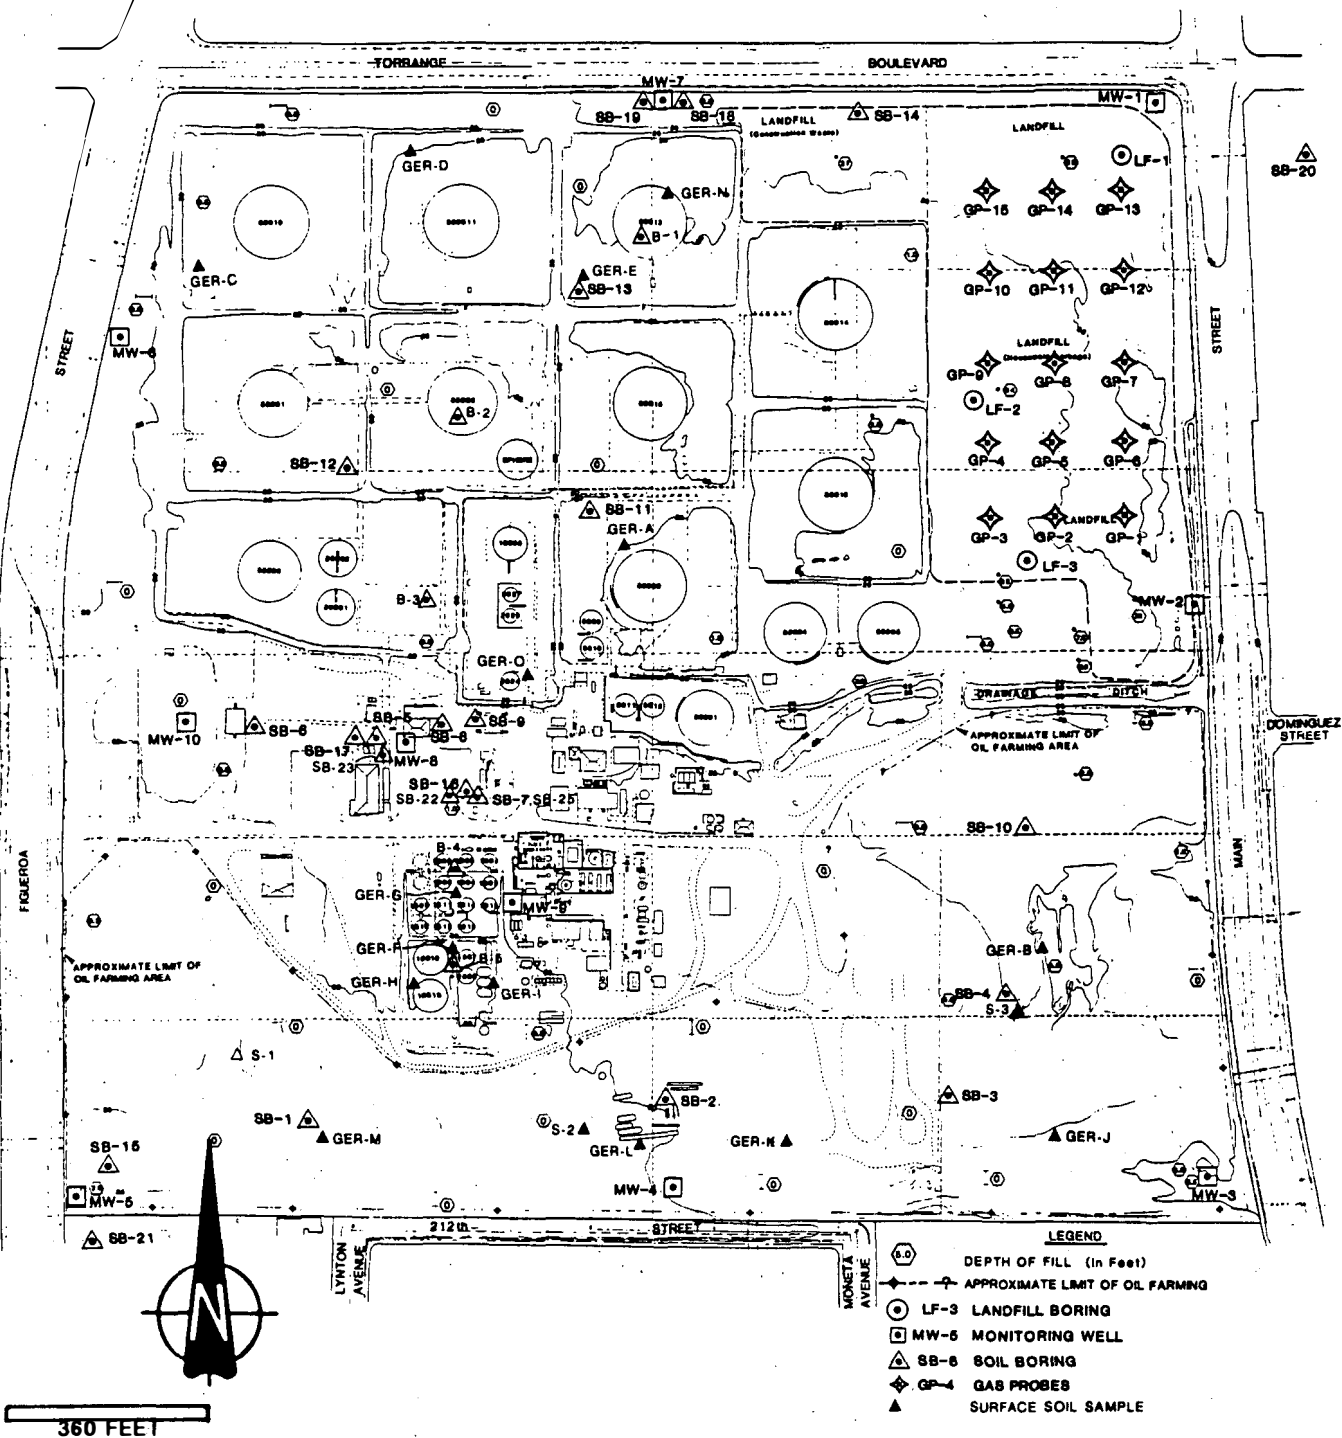
Figure 2-1 LOCATION OF MONITORING WELLS, SOIL BORINGS AND GAS PROBES
GOLDEN EAGLE REFINING COMPANY
CARSON, CALIFORNIA

Initial site characterization work was performed in June 1985 and included the installation of nine on-site monitor wells (MW-10 was drilled in November 1984) (see Figure 2-1). These wells were drilled to 80 or 90 feet and completed in the semi-perched aquifer. Twenty-one soil borings were also drilled at this time. SB-1 through SB-14 were drilled to 15 feet and sampled for hydrocarbons every five feet. SB-15 through SB-21 were drilled to 60 feet and sampled at the 5, 10, 15, 25, 40, and 60 foot depths. In addition, three borings were drilled through the landfill to determine if the groundwater beneath the landfill was contaminated (4).

The results from this initial work showed that two of the wells, MW-2 and MW-8, contained chlorinated hydrocarbons at concentrations greater than California maximum contaminant levels (MCLs) for drinking water or recommended drinking water action levels provided by the California Department of Health Services (DOHS) (see Table 2-2) (4). MW-2 is on the east side of the site, on the edge of the landfill. MW-8 is in the support facilities area of the refinery, near an old underground waste

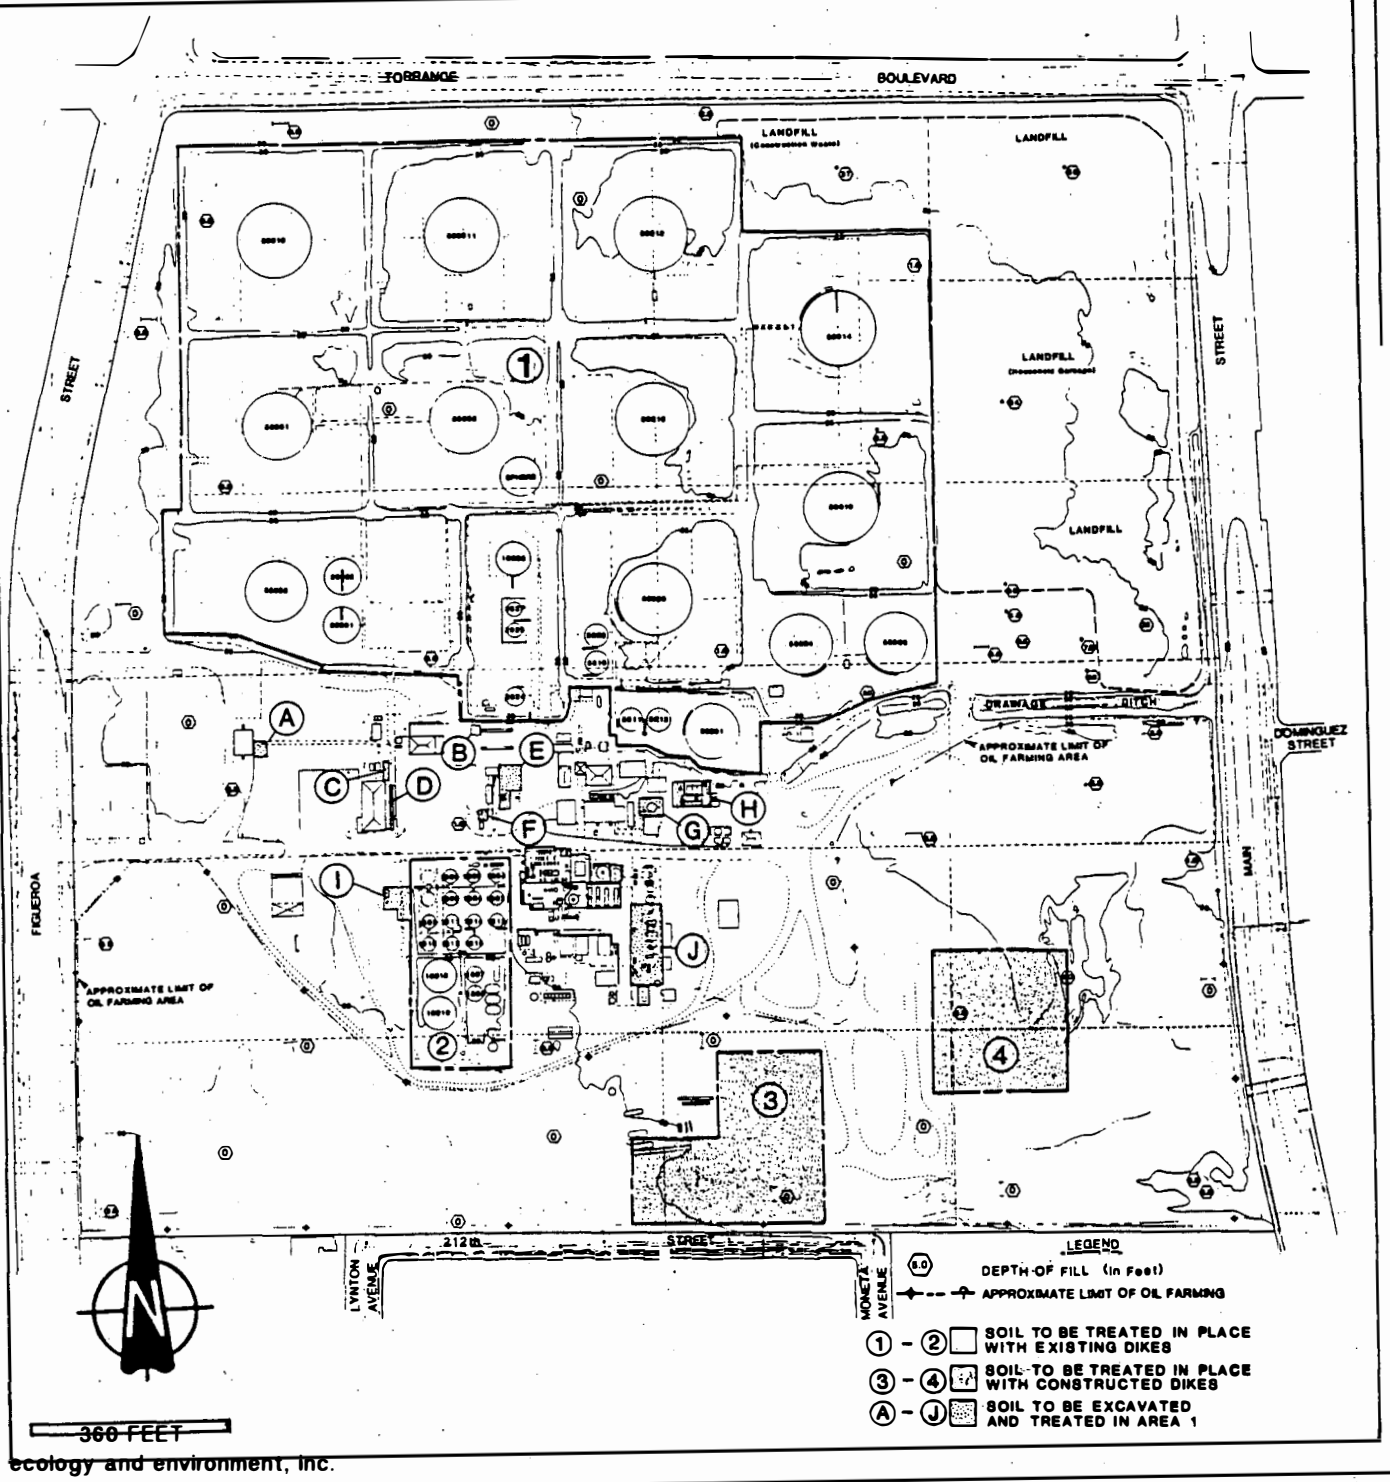
Figure 2-2 BIOAUGMENTATION TREATMENT AREAS
GOLDEN EAGLE REFINING CO.
CARSON, CALIFORNIA

Bright and Associates estimated that 23,700 cubic yards of hydrocarbon-contaminated soil needed to be either treated or removed. This estimate included soil from the support facilities area, tank farms, and the landfarming area. Rather than excavating and disposing of this soil off-site, Golden Eagle received a variance from the DOHS to treat the soil using in-situ bioaugmentation (7). SOLMAR Corporation was retained to perform the treatment. Four areas were set up to be treated (see Figure 2-2). The asphaltic material that covered the berms surrounding the tank farms was scraped into the interior of the large tank farm (treatment area 1). The interior diking of the tank farm area was graded and disked into the surrounding area. All visibly contaminated soil from 10 locations throughout the processing and support areas (treatment areas A through J) was excavated and spread into the large tank farm area. Additional soil removed and placed in the large tank farm area included soil to a depth of five feet around MW-5, MW-6, MW-7, and SB-14, and soil to a depth of 25 feet at SB-5 and SB-7 near the location of the former underground storage tanks in the support facilities area. The bioaugmentation process involved the addition of nutrients and bacteria specifically cultured to digest the hydrocarbons present in the soil (8).

In addition to the bioaugmentation of hydrocarbon-contaminated soils, approximately 194 cubic yards of soil containing elevated levels of lead were removed from a portion of the landfarming area. An area measuring about 112 feet by 112 feet by 5 inches was excavated and disposed of off-site (disposal location unknown) (9).

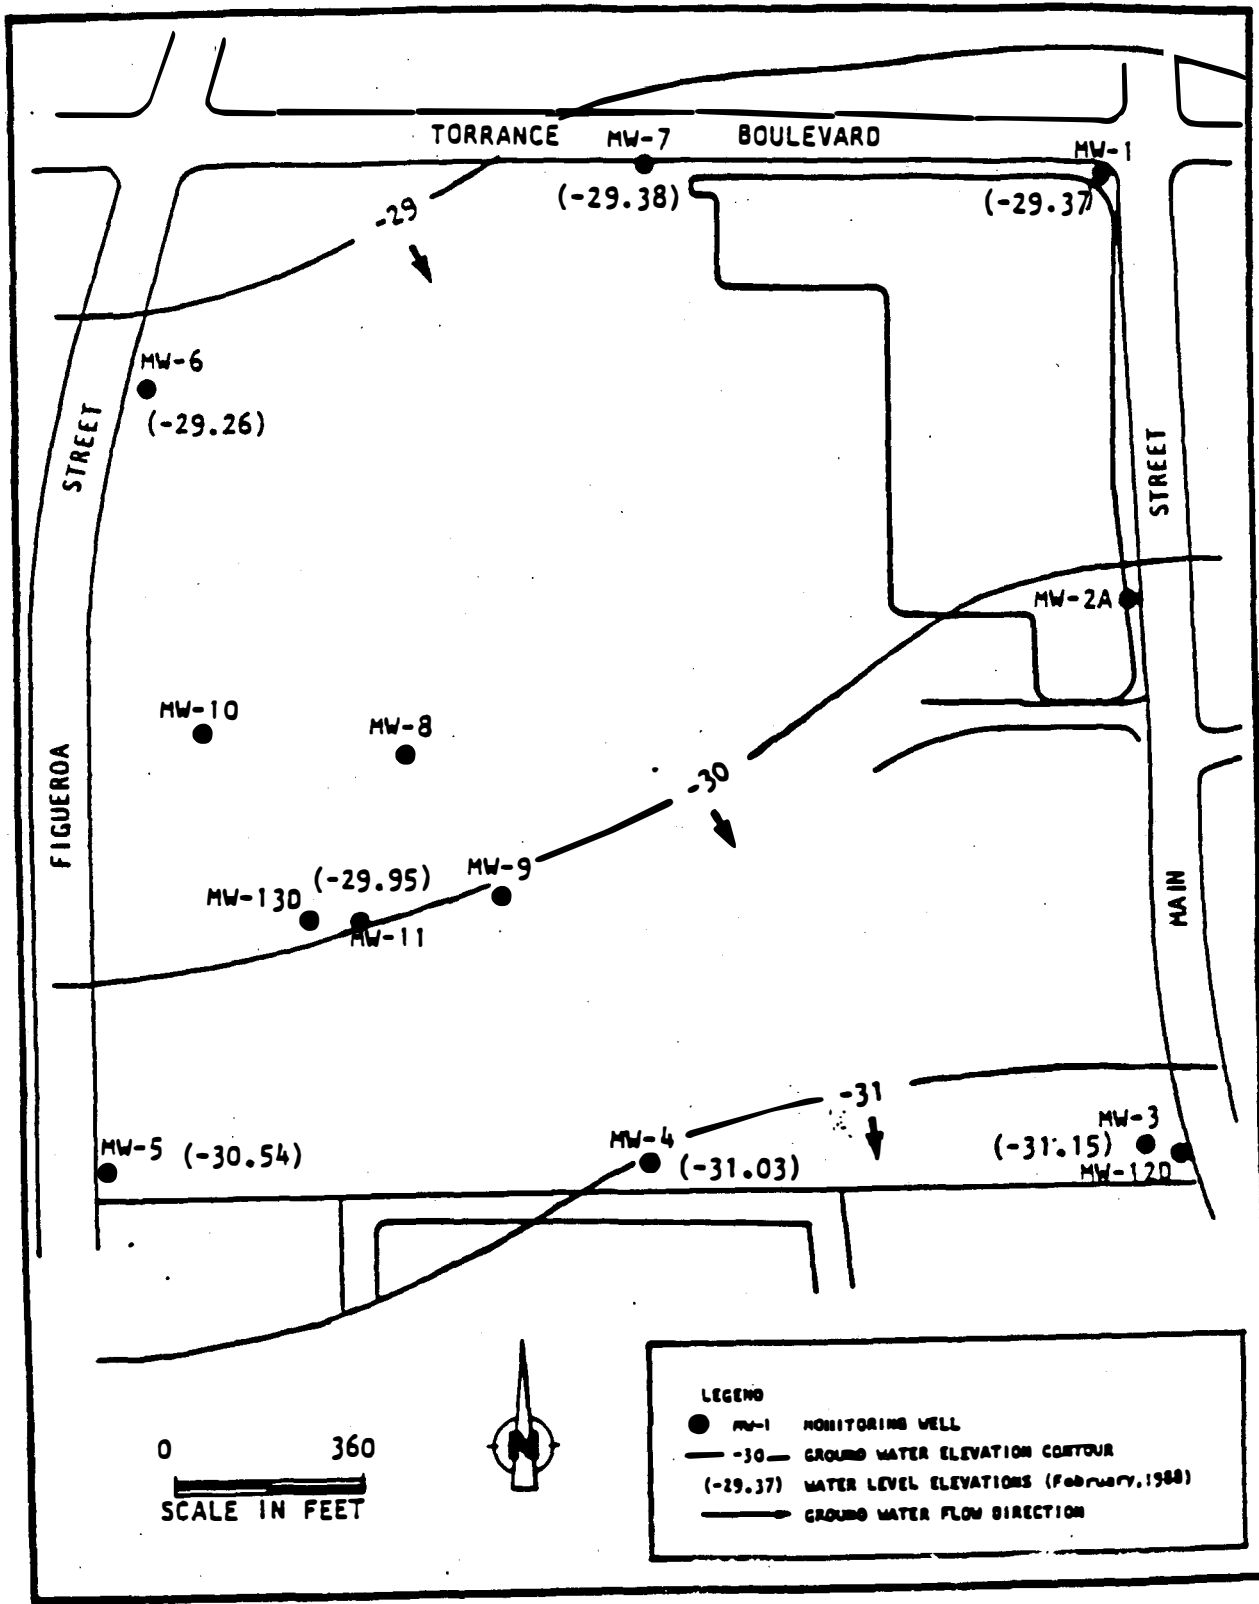
Figure 3-1 SEMI-PERCHED GROUNDWATER CONTOURS - FEBRUARY 1988
GOLDEN EAGLE REFINING COMPANY
CARSON, CALIFORNIA

Due to the northwest to southeast water-level gradient of the semi-perched aquifer, MW-6 and MW-7 are background wells for the support facilities area of the site (see Figure 3-1). None of the samples from either well contained detectable concentrations of chlorinated hydrocarbons. MW-1 is located in the northeast corner of the site and is also upgradient of the site. Samples from this well contained vinyl chloride, trichloroethene, 1,1-dichloroethane, and 1,2-dichloroethane at concentrations greater than their MCLs or DOHS action levels. Other chlorinated hydrocarbons were detected in the samples. There are several former waste management areas (landfills) in the vicinity of Golden Eagle that may be contributing to the contamination of the semi-perched zone (1,2). For this reason, it may be difficult to attribute contamination found in the semi-perched aquifer to the Golden Eagle facility. No samples from upgradient wells completed in the Gage aquifer were available for comparison to the deeper wells on-site.

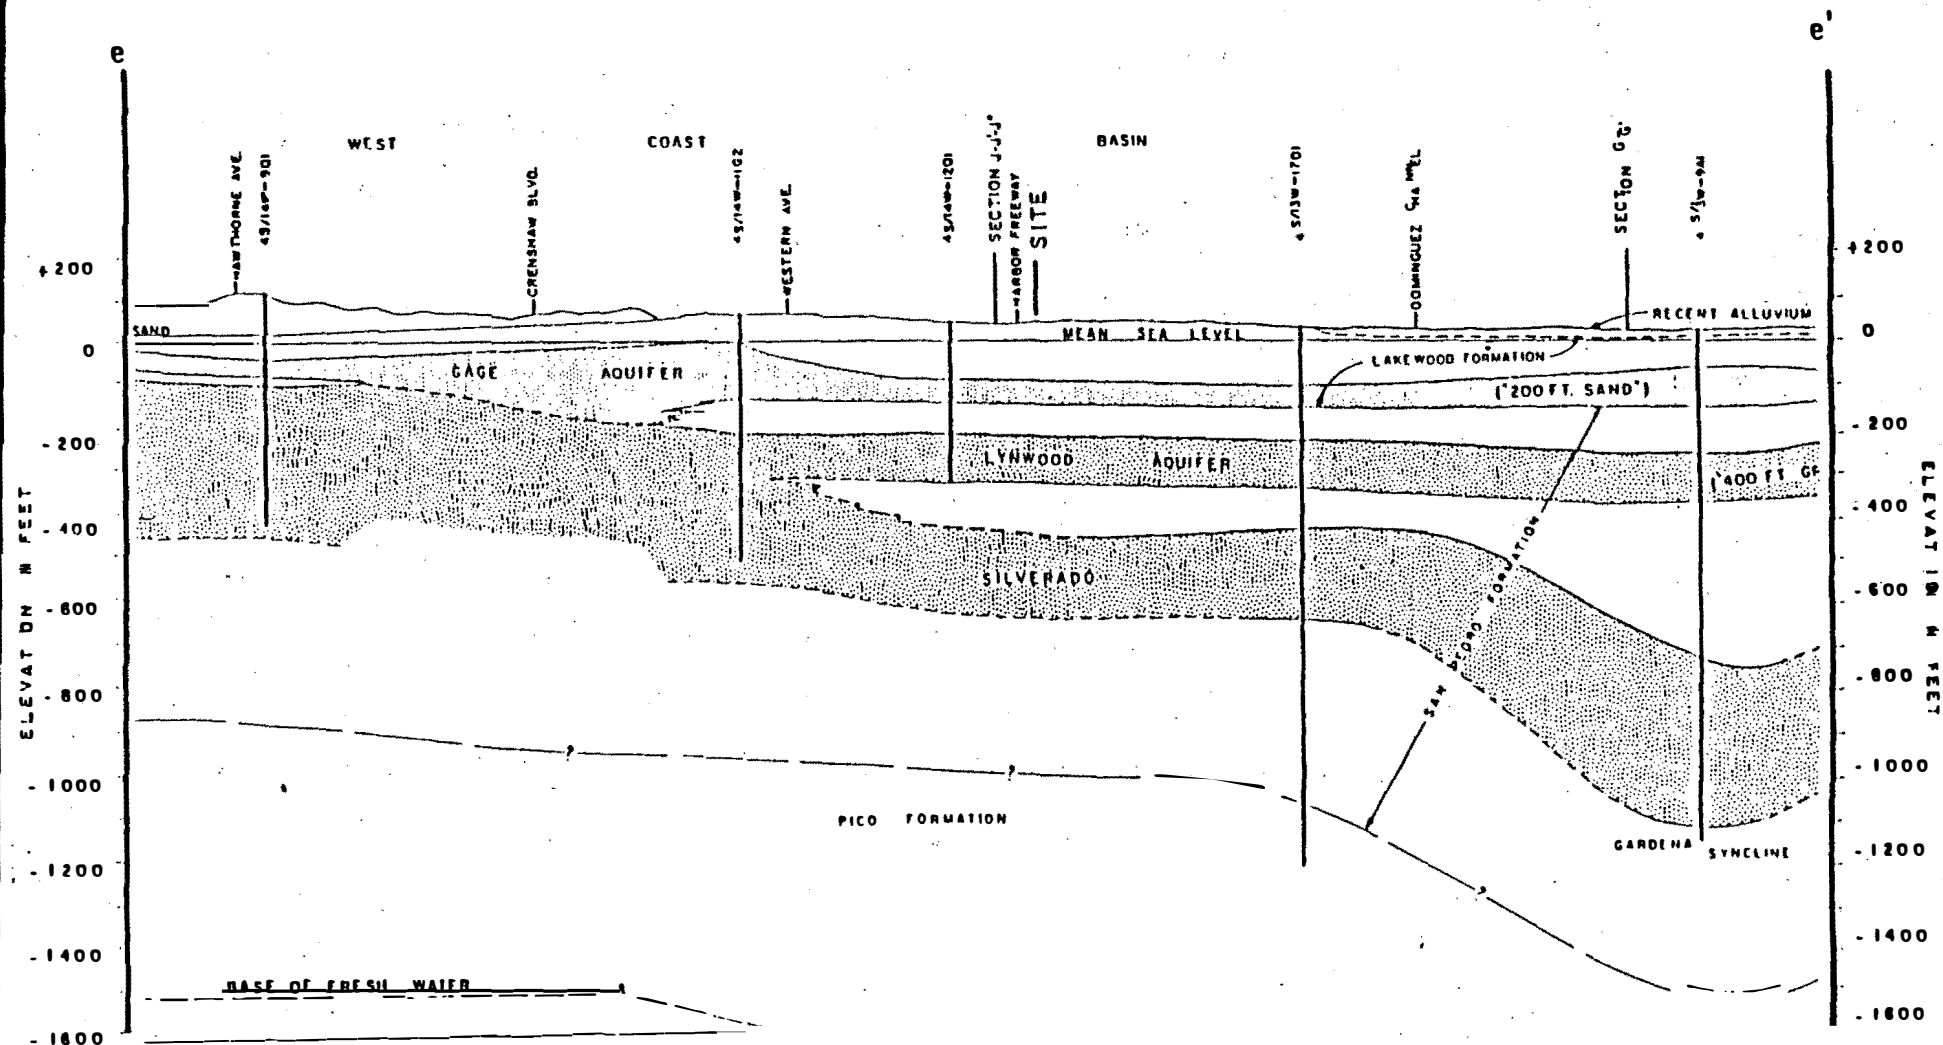
Figure 3-2 GEOLOGIC CROSS SECTION
GOLDEN EAGLE REFINING COMPANY
CARSON, CALIFORNIA

Sediments of the Lakewood and San Pedro formations of the Pleistocene age underlie the site. In this area, the Lakewood formation includes the semi-perched aquifer, the Bellflower aquiclude, and the Gage aquifer. The Lynwood and Silverado aquifers compose the San Pedro formation (see Figure 3-2).

There is a 24 to 26 foot interval of layered clayey sand, silt, and silty clay beneath the semi-perched aquifer beginning at about 115 feet below land surface. This layer is often referred to as the Bellflower aquiclude. In the two deep wells installed on-site, the permeability of this material ranged from 4.09×10^{-5} centimeters per second (cm/sec) to 1.9×10^{-7} cm/sec (15). Although these layers may limit the interchange of water between the semi-perched and Gage aquifers, based on these permeabilities, they do not represent an impermeable boundary (2).
